Emergency Response Plan Documentation Report

Former Plainwell Paper Mill Banks

Plainwell, Michigan

February 2009

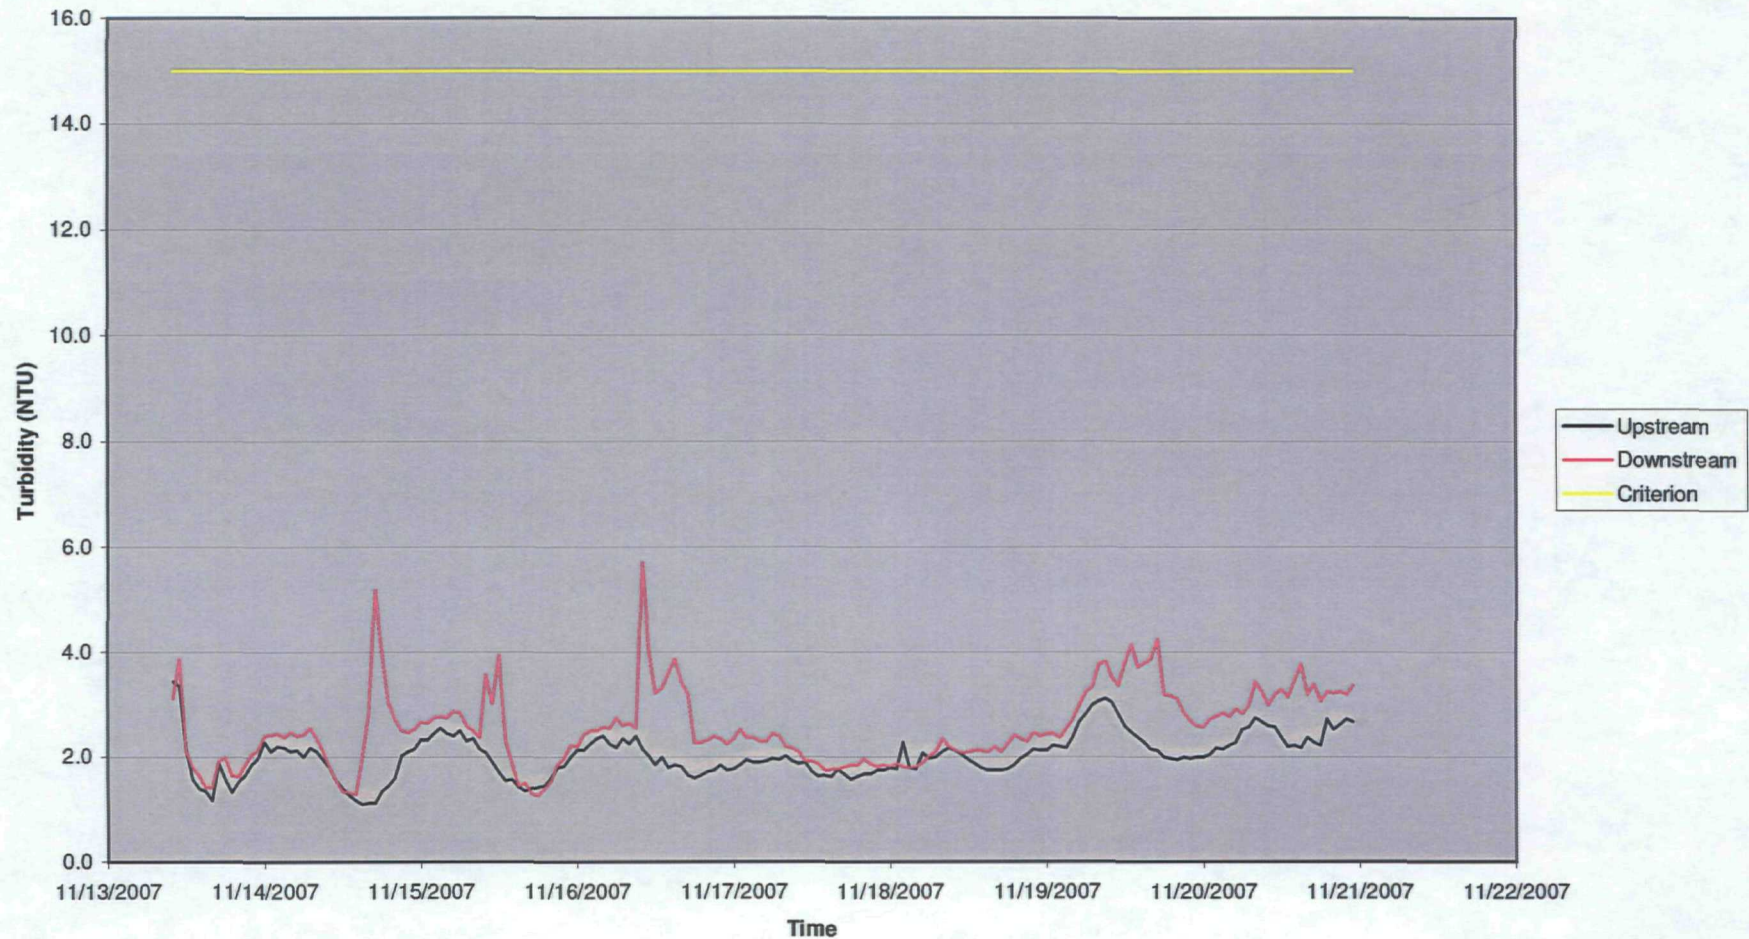
Figure 8-1
Turbidity Data - Zone A: 11/13/2007 to 11/20/2007
Former Plainwell Mill Banks Emergency Action - Plainwell, MI

Note:
Actions taken regarding exceedances are explained on Table 2.

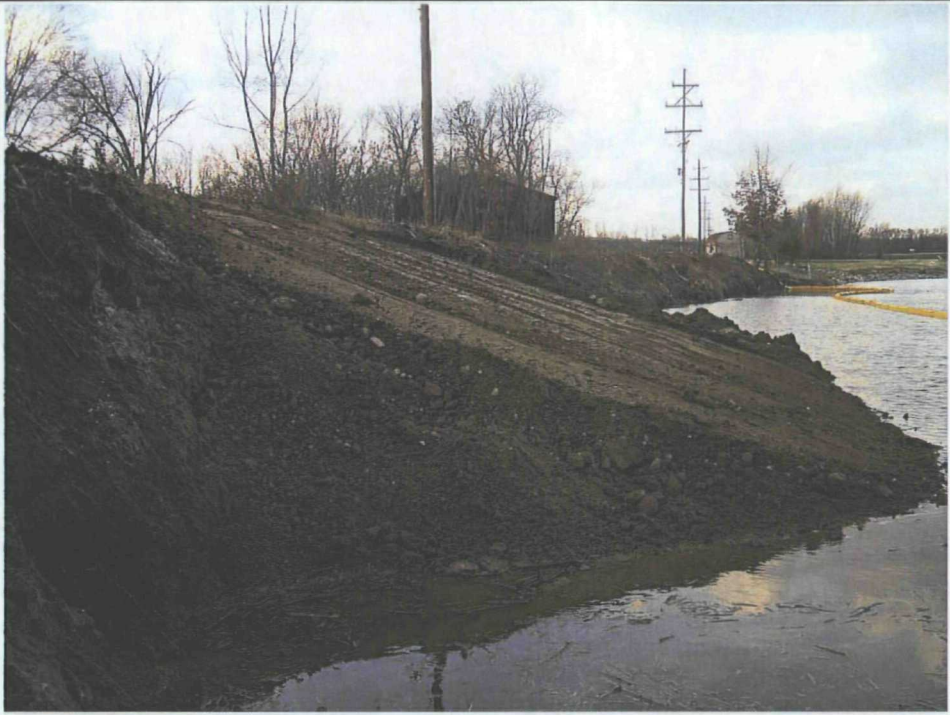
Client Name: Weyerhaeuser		Site Location: Plainwell, Michigan	Project No.: 00-05130.06
Photo No. 17	Date 11/29/2007

Description Backfill placed to stabilize the banks in Zone A after completion of the removal action.			
Photo No. 18	Date 12/04/2007

Removal of all visible residuals in the western half of Zone A required excavation of the toe and a large portion of the bank slope leaving a potentially unstable bank condition (see photographic log in Appendix B). The Emergency Action Design Report called for reworking of the banks post-excavation in order to establish a slope no more prone to erosion than the original bank. In order to accomplish this, sandy clay fill was placed along the banks at a 2H:1V slope. Cutting back the banks was not an option due to the large amount of Mill property that would be lost and the presence of utility poles near the current top of bank. The bank was armored with river run rock and rip-rap placed from the toe of the new slope to 2 feet above the river water level at the time of placement.

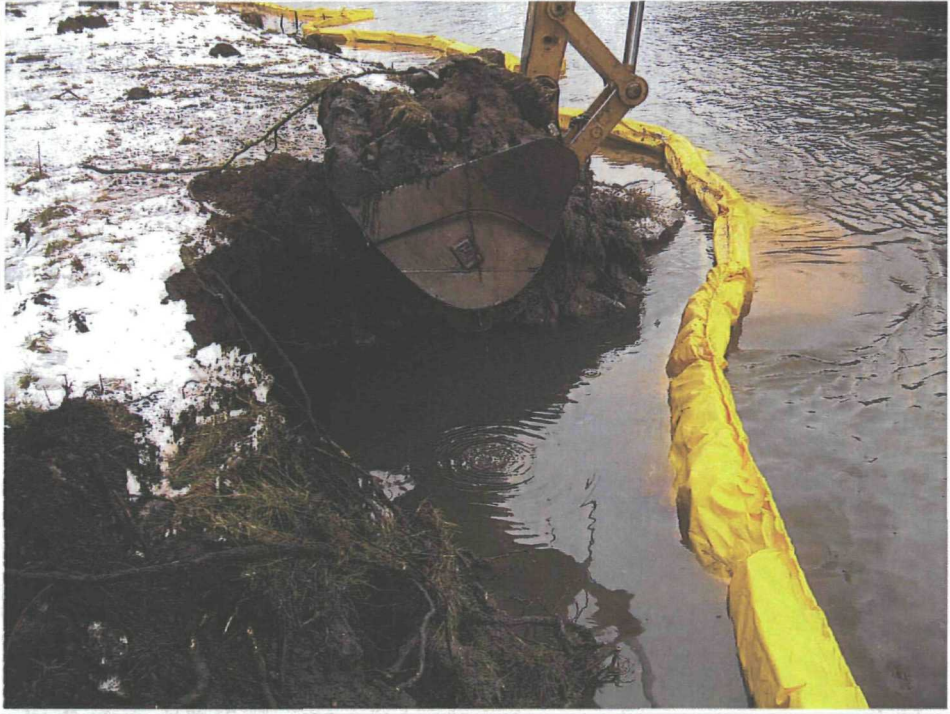
Client Name: Weyerhaeuser		Site Location: Plainwell, Michigan	Project No.: 00-05130.06
Photo No. 23	Date 2/5/08

Description Area D – Construction debris encountered			
Photo No. 24	Date 2/5/08

After the sample was collected, a layer of this clay fill material was then placed over the oily concrete rubble to prevent any additional release of material to the river. After placement of the clay cap, no visible sheen was observed on the water and oil booms were removed from the river at approximately 7:00 p.m. EST on February 5, 2008. The incident was reported to the National Response Center (Incident Report No. 867374) (see Appendix C).

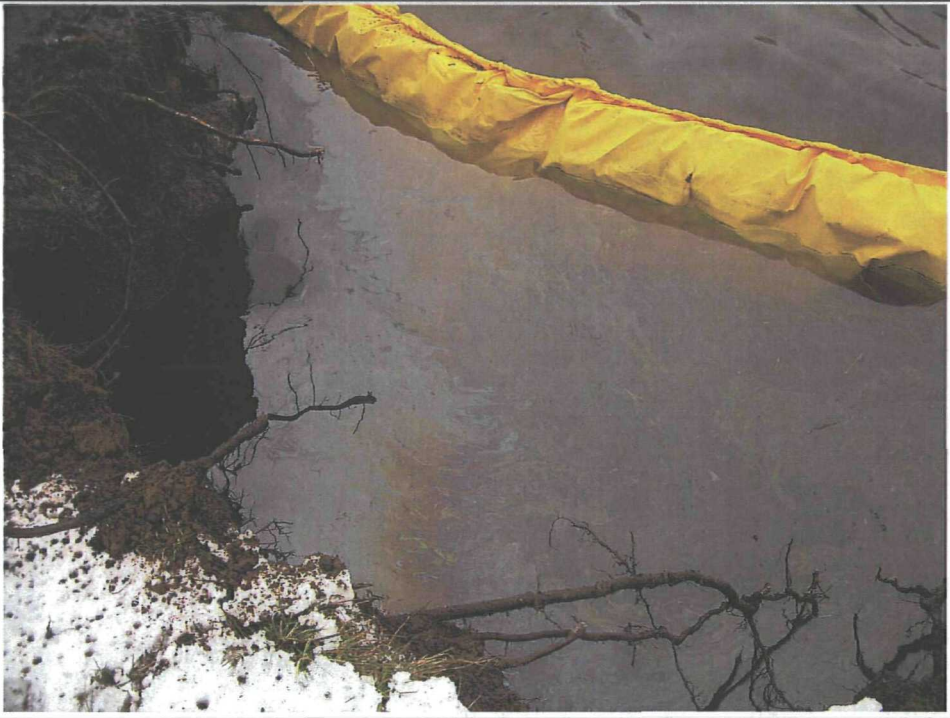
Description Slight sheen created from penetrating construction debris

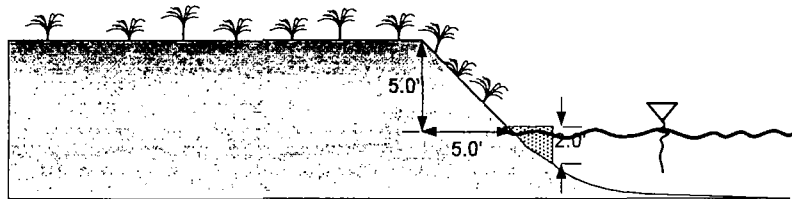
1 - ZONE D PRIOR TO EXCAVATION

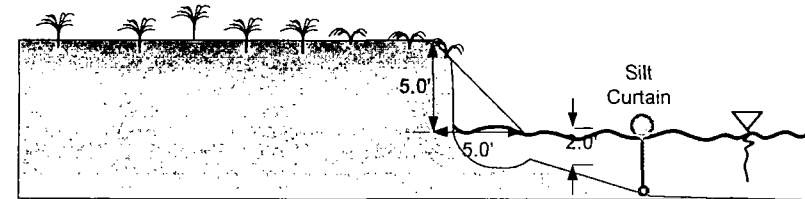
2. ZONE D AFTER EXCAVATION COMPLETE

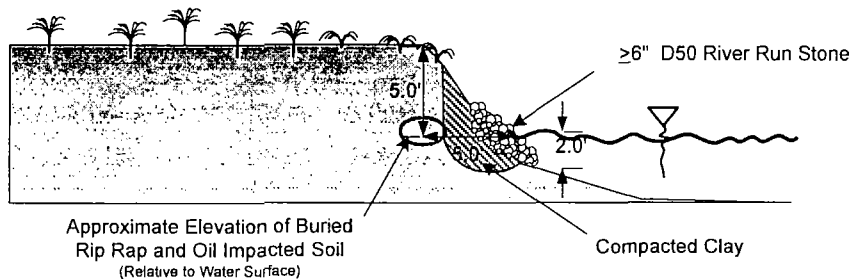
3. ZONE D AFTER CLAY PLACEMENT AND ARMORING
